A Little Flood Geology

Part II: Examples from Central Montana

Peter Klevberg*

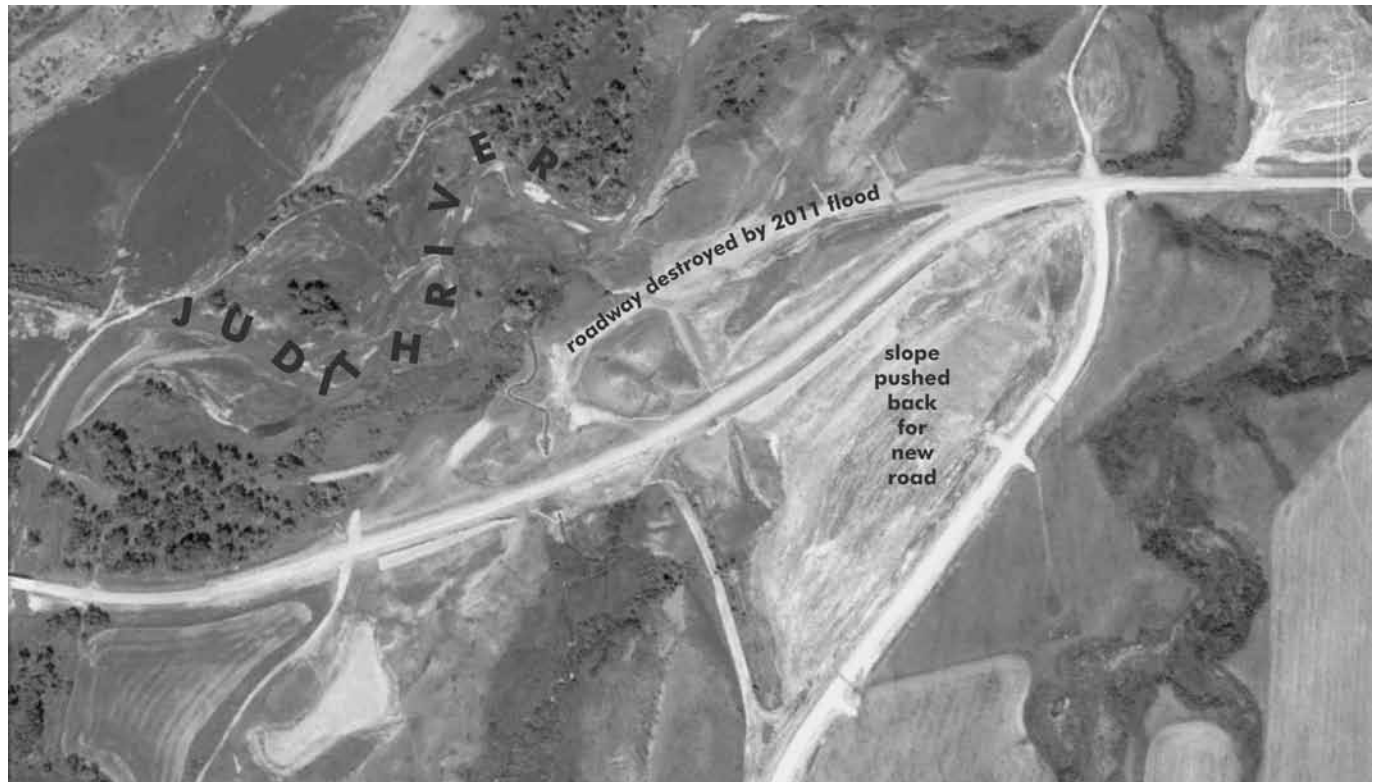
Figure 3. Aerial view of Hanover Road west of Lewistown, Montana, showing large amount of earthwork necessary to relocate road away from edge of valley where 2011 flood seriously damaged the road. Photograph taken 2014, obtained from Google Earth.

Judith River. The Judith Basin, the area between the Little Belt and Moccasin Mountains (Figure 1) drained by the Judith River, experienced localized mass wasting (slumps, landslides, etc.) and washouts. Many roads and bridges, including important bridges northwest of Lewistown, were damaged. The Hanover Road, connecting the areas east and west of the Ross Fork of the Judith River, was cut by a landslide, closing the

road for an extended time (Figure 3). I observed some of the geotechnical field work for its rerouting. Downstream of the road bridge is the dramatic Central Montana Rail steel trestle (Figures 4, 5). While data for the Judith River are

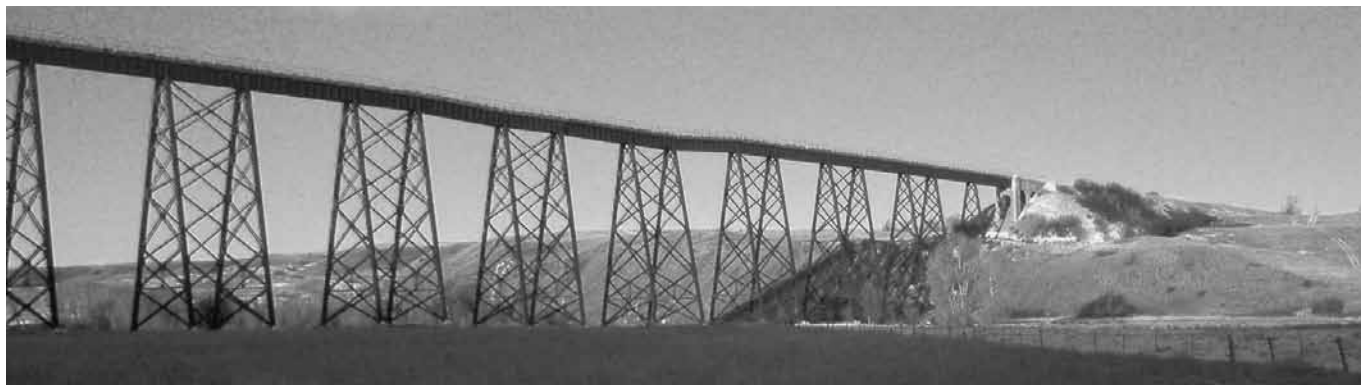
Figure 5. West half of Judith River trestle in 2011 after Judith River flooding damaged it (note misalignment of bridge spans).

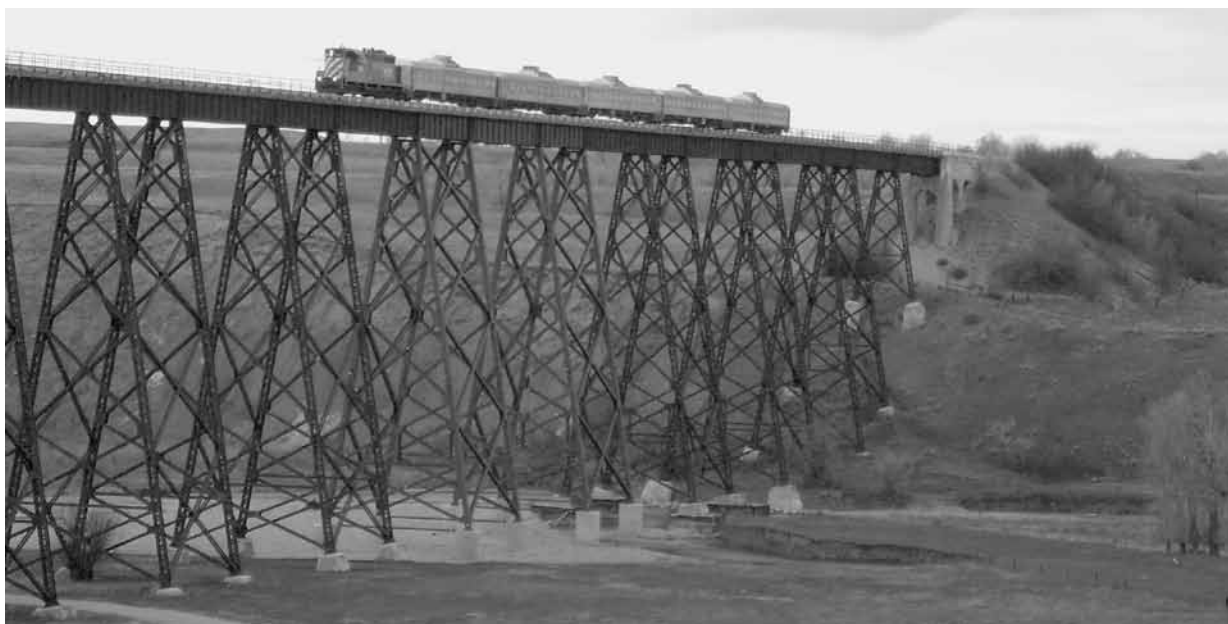
Figure 10. The first revenue train following repair of the viaduct was the *Charlie Russell Chew Choo* dinner train on November 21, 2014. Grain trains still had to wait for repair of the Ross Fork Bridge. Note the new piers supporting bents directly under the train. Photograph courtesy Central Montana Rail.

nificant damage to the bridge (Figures 8, 9). The span was closed to traffic for 3½ years until repairs could be made (Figure 10).

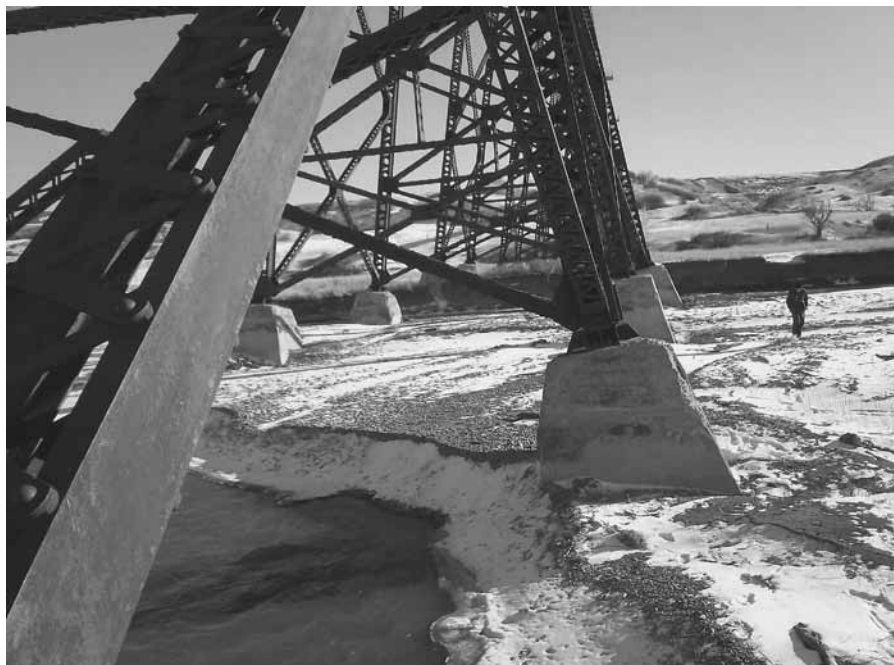
Figure 11. Wide gravel bar deposited by 2011 flood buried the pre-2011 river channel. Author (at right) provides scale.

The natural course of the river during normal flow was thus redirected northeast against the bank (Figures 6, 9). The channel formed between 1996 and 2011 was filled with gravel and a thick, flat-topped gravel bar was deposited over it the entire distance from the 1996 channel to the new channel (Figure 11). Any small flood would follow the east side of the new gravel bar and cut further into the unconsolidated material at the bend. I had suggested cutting a channel to speed this natural process so the river would immediately occupy its future course and leave most of the bridge unthreatened. However, the likely difficulty of obtaining the required environmental permits convinced the involved parties to simply armor all of the bridge piers and let the river continue to run lengthwise under the bridge. Ironically, the construction equipment during bridge repair managed to incidentally divert the river back toward its previous course. The indicated future course of the river is therefore less certain, but it may well be carved as shown by some future flood event. Relatively little change (at least, without large machinery!) occurs in the meantime.

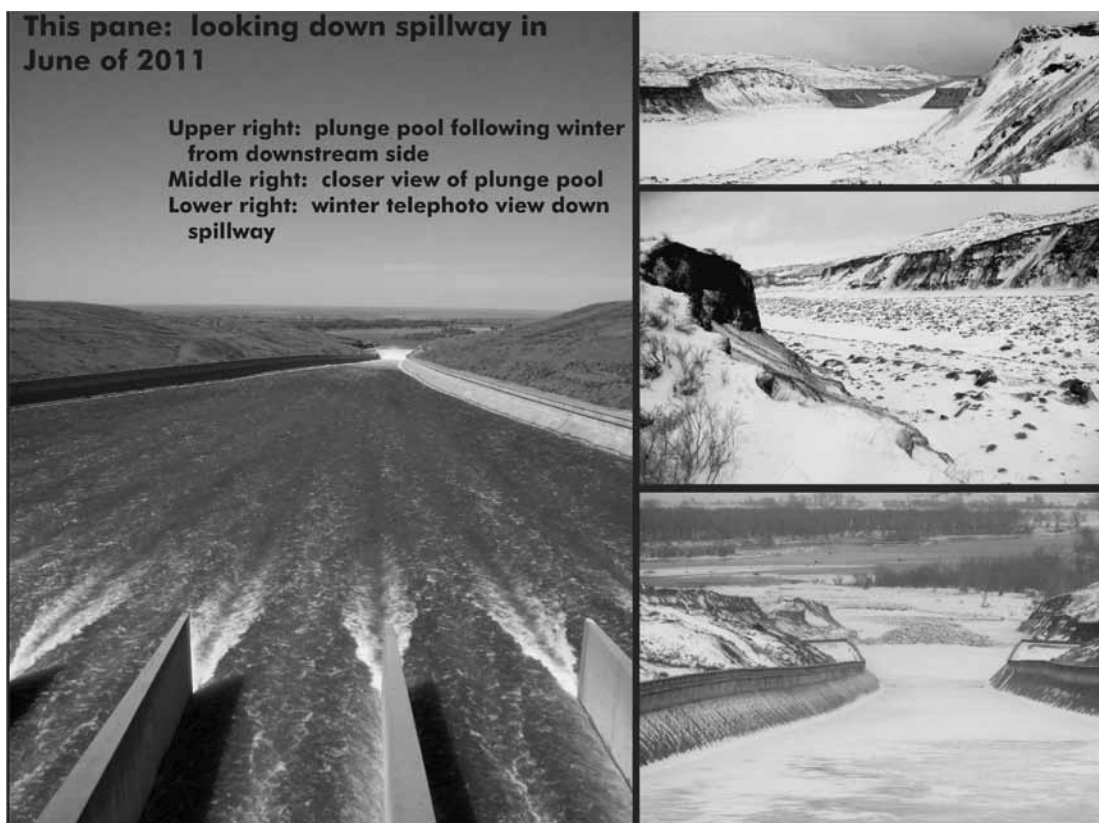
Figure 12. The spillway for Fort Peck Dam is located away from the dam in terrain eroded into Bearpaw Formation sedimentary rocks.

When I saw the spillway in June of 2011, it was flowing approximately $1,866 \text{ m}^3/\text{s}$ (65,900 cfs). The plunge pool was masked by a towering cloud of spray (Figure 12). Considerable damage occurred to the plunge pool where the flow eroded away the soft Bearpaw shale and undermined some of the concrete. An extensive reconstruction and reinforcement program was designed by the U.S. Army Corps of Engineers and included refilling the deepened plunge pool using roller compacted concrete. Such rapid flows (supercritical flow) elsewhere have been documented to remove hard rock and concrete, especially where cavitation has ensued (Holroyd, 1990).

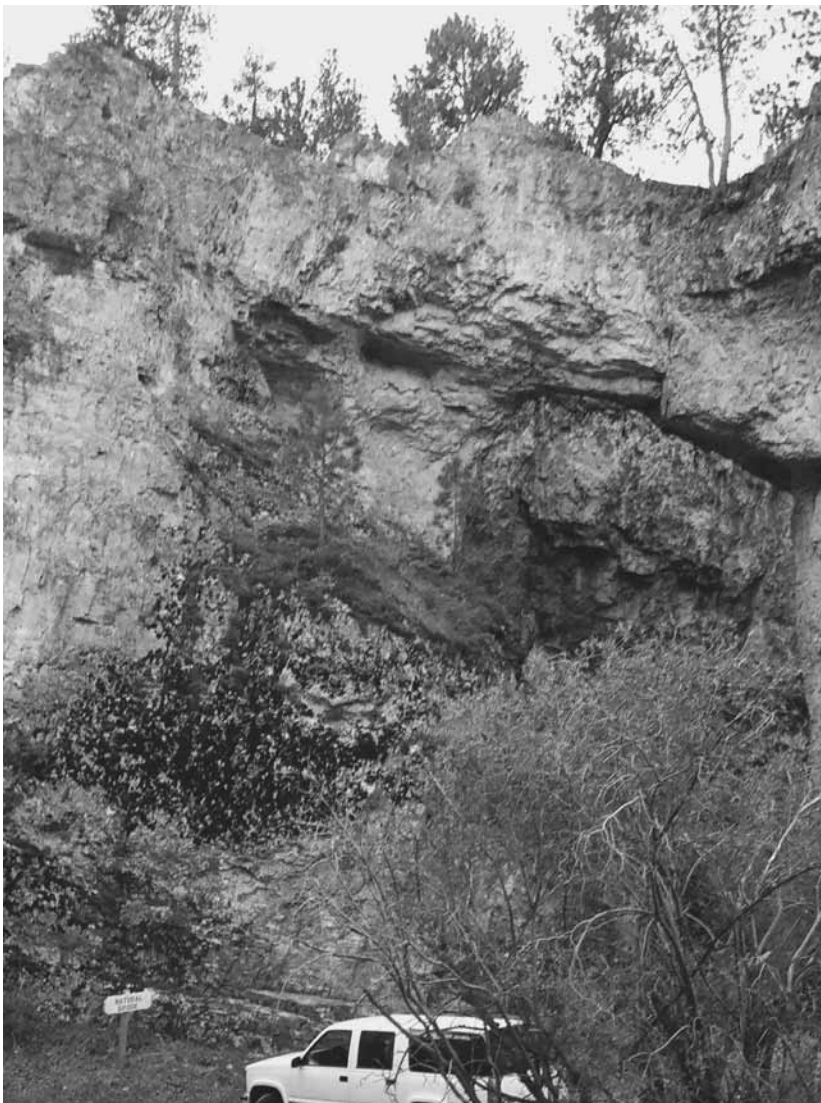
Figure 14. The best-known natural bridge in Mission Canyon, photographed in 1999.

A gravel road was built decades ago between the creek and the canyon walls. The Mission Canyon Formation is karstic limestone with an abundance of natural bridges (arches) and caves (Figure 14). In 2011, floods scoured the canyon and removed the road, leaving it accessible only by foot. In Hays, the

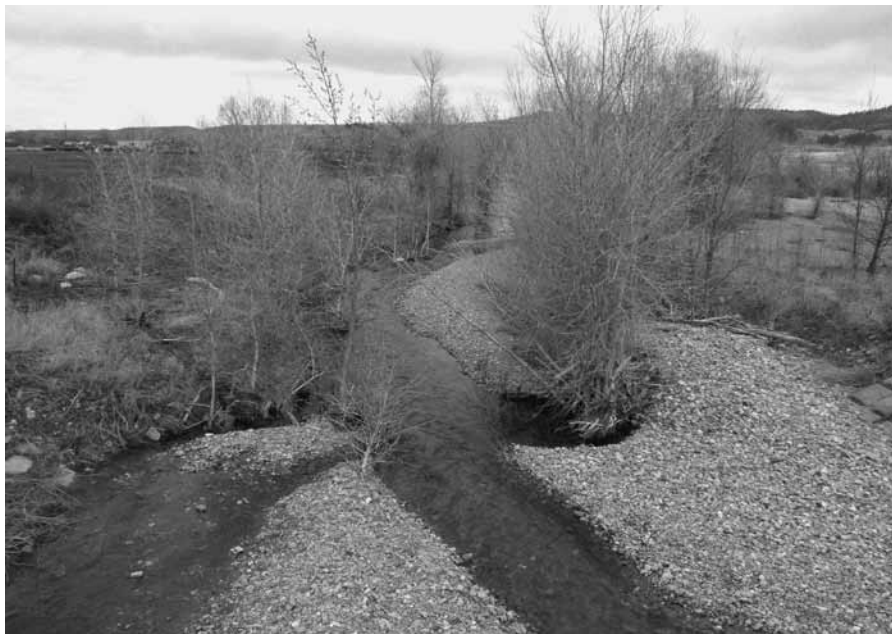
Figure 16. Little Peoples Creek at Saint Paul Mission after it began running again in 2012. Photograph courtesy Roman Catholic Diocese of Great Falls, Billings.
