## THE 1993 MIDWEST FLOODS AND RAPID CANYON FORMATION

GLEN W. WOLFROM\*

*The processes which creationists postulate may be responsible for rapid canyon formation were vividly demonstrated during the floods which occurred in the Midwest during the summer of 1993. Erosion damage to spillways at three sites is described: Tuttle Creek Lake on the Big Blue River at Manhattan, Kansas; Coralville Lake on the Iowa River at Coralville/Iowa City, Iowa; and Milford Lake on the Republican River near Junction City, Kansas. Each location involved not only the removal of overburden, but also rapid erosion of the underlying strata. Details of duration, water volume, and water flow rates are presented and, where possible, these data are compared to those of prehistoric flood catastrophes. It is shown that extensive erosion in a short period of time is possible even in relatively well-consolidated and lithified strata, and that the pattern of erosion sometimes is remarkably similar to certain features found in the Grand Canyon. Additionally, brief descriptions of strata and fossils are provided.*

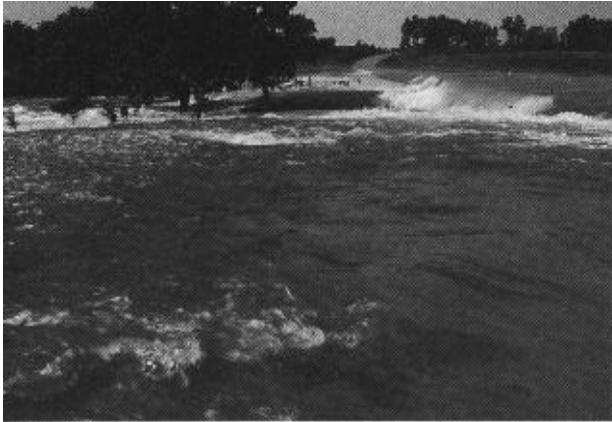
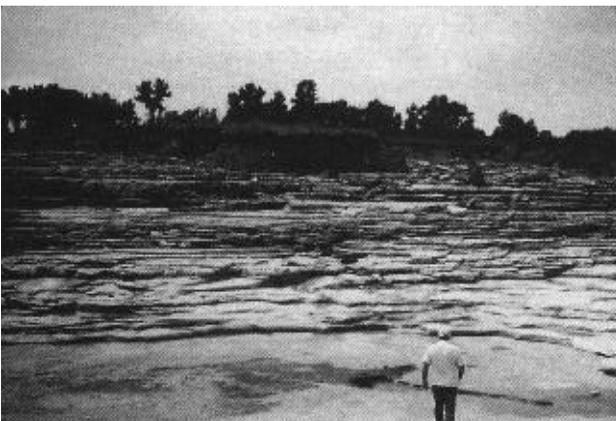
**Figure 1. Flood damage at emergency spillway of Milford Lake. Photographs by U.S. Army Corps of Engineers. a. Photograph taken on 23 July 1993 a few hours before the breach occurred. b. Breach in dam (10 August 1993). Note person standing in channel of eroded bedrock near center of photo. c. Eroded bedrock above the spillway dam (10 August 1993).**

On 20 July 1993, water began flowing through the emergency spillway of Milford Lake. Three days later the earthen spillway dam and the road atop it (Kansas State Highway 244 Spur) were breached, producing extensive erosional damage as a result of the rushing flood waters (Figure 1). Water flowed through the

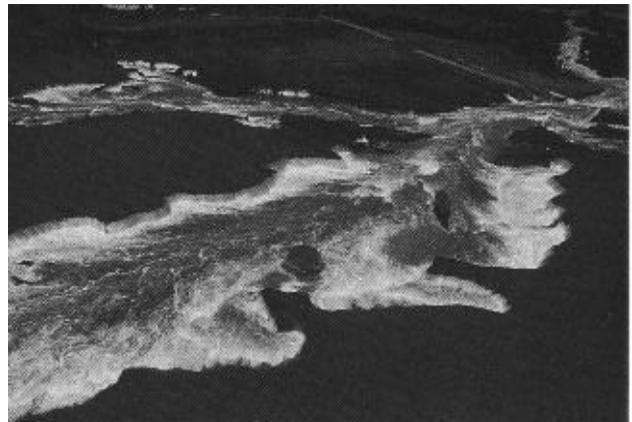
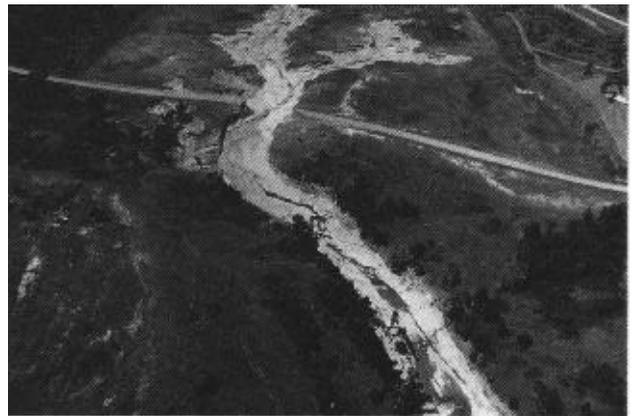
**Figure 2. Aerial views of flood damage at emergency spillway of Milford Lake. Photographs by U.S. Army Corps of Engineers. a. View downstream during the flooding (25 July 1993). The road indicates the location of the spillway dam. b. View upstream after the flood waters had receded (6 August 1993). Again, the road marks the location of the spillway dam.**

It is noteworthy that erosion occurred in the spillway both above and below the dam (Figure 2). In the approach channel above the spillway dam, both valley

sediment fill and the top layer of shale (Holmesville Shale) were removed exposing and eroding the underlying Fort Riley Limestone. Of special interest is the pattern of erosion which occurred above the dam. In Figure 2b one can readily see structures which are remarkably similar to side canyons and temples (or buttes) found at the Grand Canyon. Erosion of the limestone continued in the channel below the spillway.

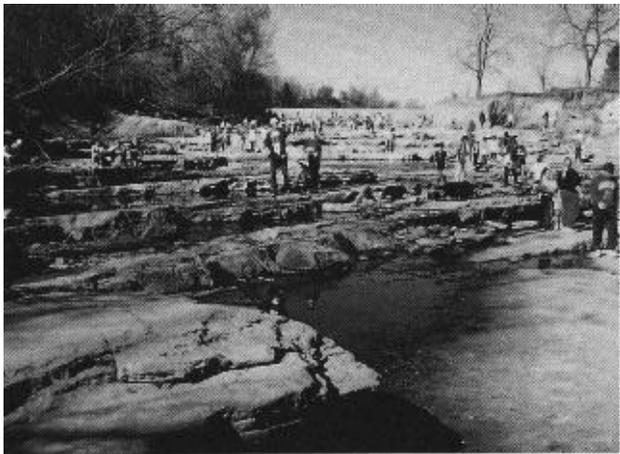
Figure 4. Erosion damage in spillway channel at Coralville Lake. The concrete spillway is visible in the background.

Figure 4 provides a view of the resultant erosional damage below the spillway, with the concrete spillway

itself visible in the background. A 15-foot channel was eroded into the underlying bedrock (Anon., 1993), exposing limestone which by uniformitarian standards is said to be of Devonian age (viz., some 375 million years old). As is evident in the photograph, a steady stream of visitors (park rangers stopped counting at 150,000) has taken advantage of this rare opportunity to view these rock formations both horizontally and vertically. In addition to the corals mentioned earlier, a number of other fossils could be observed in plenitude, especially brachiopods and crinoid stems (Figure 5). Also observable were fossilized ripple marks and worm burrowings. The public was not allowed to remove materials from the site, but some specimens were excavated for further study by the Iowa University Geology Department.

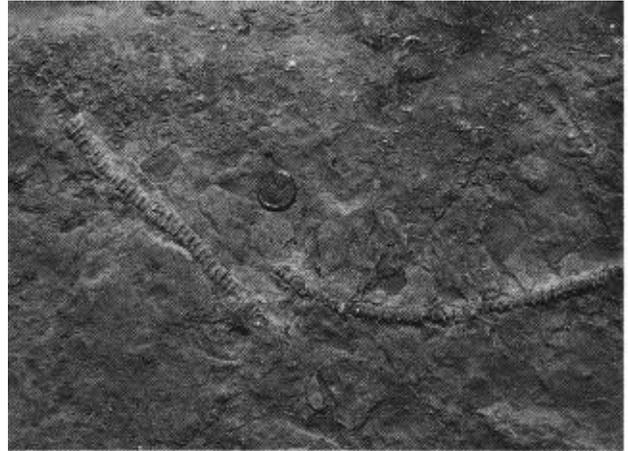
Figure 5. Fossil crinoid stems at Coralville Lake spillway. Crinoids (sea "lilies") are marine invertebrates of the class Crinoidea, phylum Echinodermata.

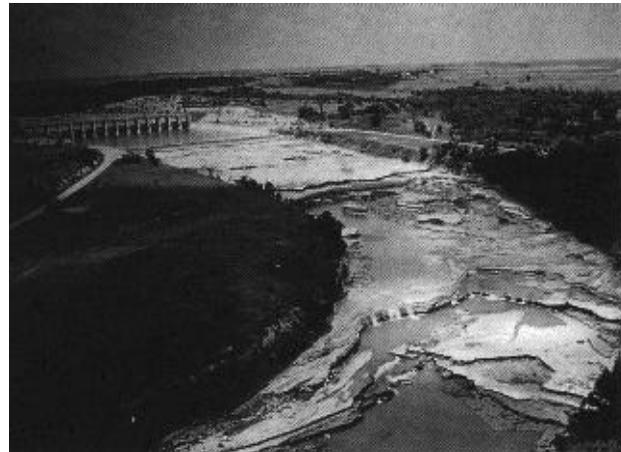
**Figure 7. Aerial view of Tuttle Creek Lake spillway area. Photograph by U.S. Army Corps of Engineers.**

On a grander scale is the erosion that occurred below the spillway at Tuttle Creek Reservoir when all 18 floodgates were opened (Figure 7). In fact, the area is now referred to as the "Grand Canyon of Manhattan," the "Little Grand Canyon," or simply the "Manhattan Canyon." Kansas State University geologists have stated that the Grand Canyon of the Colorado and the Manhattan Canyon were formed by similar forces (Archer et al., 1993; Blakeman, 1993), but that the recent flood waters "carved out this small canyon much faster than water and wind sculpted the Grand Canyon" (Blakeman, 1993).

Figure 7 shows an aerial view of the entire area. The spillway apron itself is approximately 840 ft wide by 580 ft long, and the length of the outlet channel from the top of the concrete apron to the bottom of the photo is about 2900 ft. Figure 8 provides a panoramic view of one of the most severely damaged areas several hundred yards below the spillway (approximately the area in the center of Figure 7). The spillway is to the northwest (left), and additional erosion occurred downstream of the area shown in this photograph. For scale, people walking just below the tree line on the far side of the canyon are barely visible. Structures can be seen which are again remarkably similar to those observed in the Grand Canyon, such as side canyons (alcoves or amphitheaters), caves or undercut ledges, and even temples or buttes within the canyon itself. Figures 9a through 9c, taken at progressively greater distances downstream from the spillway, demonstrate the process and the effects of headward erosion as evidenced by undercutting of the strata.

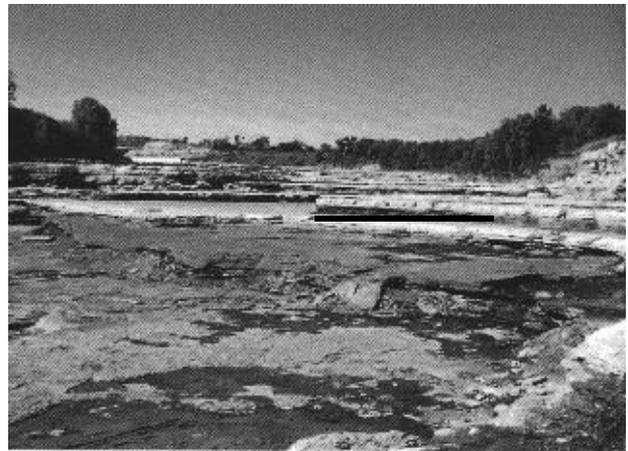
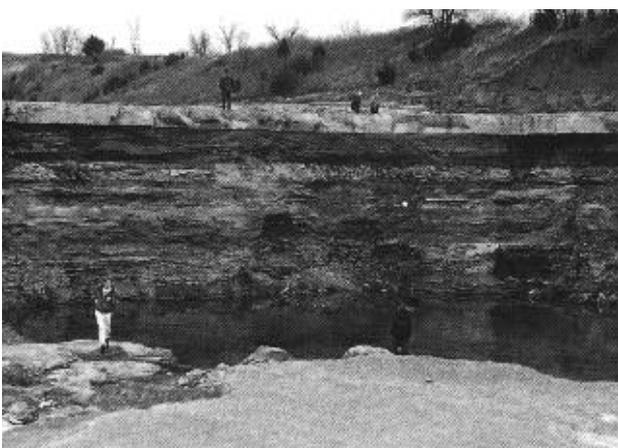
Figure 9. Photographs taken at progressively greater distances downstream from spillway apron: a. ca. 500 ft; b. ca. 1300 ft; c. 2800 ft.

A portion of the eroded region in the center of Figure 8 is viewed from south to north in Figure 9b. If

the person at the top of the ledge is assumed to be six ft tall, then one can calculate that more than 30 ft of lithified materials were eroded away by flood waters at this location alone. In total, from the spillway apron to the base of the hill downstream, nearly 100 vertical

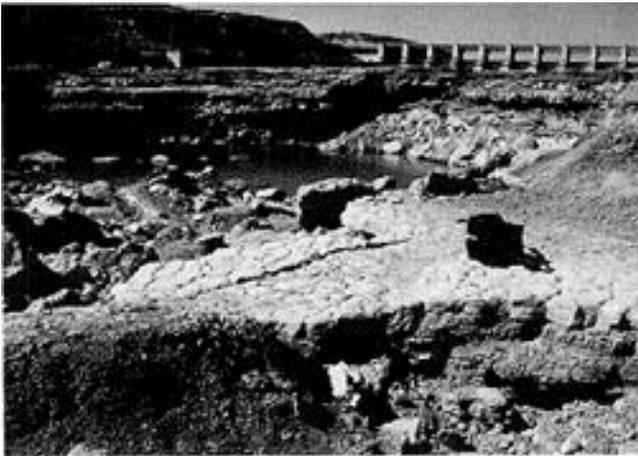
Figure 11. Fossil animal burrows (*Planolites?*; Thompson, 1992, p. 735) at Tuttle Creek Lake spillway.

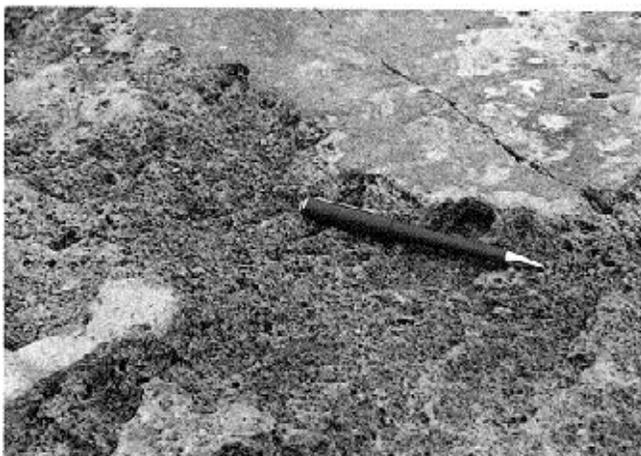
Figure 15. Pitted surface of limestone at Tuttle Creek Lake Spillway.

That cavitation may have taken place is not as evident. Holroyd (1990a, p. 24) instanced data from the Bureau of Reclamation indicating that cavitation may occur at fluid flow speeds greater than 30 meters per second (67 mph). Austin (1991b, p. 88) cited NASA data which suggest that cavitation may be associated with fluid flows as slow as 30 ft per second (20 mph). It was in fact earlier noted that water moved down the Manhattan spillway at about 30 mph, suggesting that conditions conducive to cavitation could have existed during the canyon’s formation. Figure 15 shows the pitted limestone surface at one particular location in the Manhattan Canyon, which may indicate the effects of cavitation. It is also possible that continued pulverizing and weakening of the rock and subsequent erosive action could obliterate any direct physical evidence of cavitation.
